## GRAPHALLOY® Upgrade Saves Boiler Feed Pump

***Keeping a multistage boiler feed pump operating was a problem for a gas plant...until they installed GRAPHALLOY bushings and wear rings.***

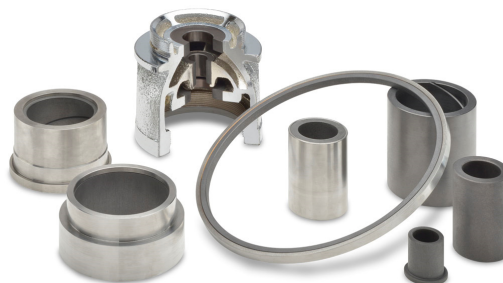
Here is what he saw: the throttle bushing showed the most wear. The sleeve under the throttle bushing was worn with radial grooves that appeared to be from contact with the stationary (plastic composite) wear part. However, in this case, the center stage (typically the first part to fail in a dry run episode or low viscosity transient) was fine while all of the hub side composite inserts were missing and the eye side inserts were unaffected. This tells us that we were looking at a completely different issue.

The engineers agreed that the cross section of the throttle bushing was so thin (only approximately 3/16 inch per side) and the pressure against the face of the bushing was so high that it deformed the plastic composite material causing it to move toward the ID.

The reduced clearance caused the bushing to ride onto the throttle sleeve. The friction and pressure caused the plastic composite material to melt and “blow out” the low pressure side. Once the throttle bushing was lost, the rotor lost its hydraulic balance within the case causing the rotor to shuttle towards the one end. The axial movement separated the mechanical seal faces and overloaded the bearing causing the pump to shut itself down. There was evidence the seal had leaked and the bearings showed signs of having thrust in one direction.

The Graphite Metallizing engineer recommended replacing the hub rings, center and throttle bushings, and eye side rings with nickel-grade GRAPHALLOY.

The GRAPHALLOY material was ordered, shipped next day, installed and the pump was quickly put back into service. The pump has been in service now for over four years with no further problems.
