GRAPHALLOY® Pillow Blocks: 20 Years of Service in a Submerged Environment

Reliable in Wastewater Treatment

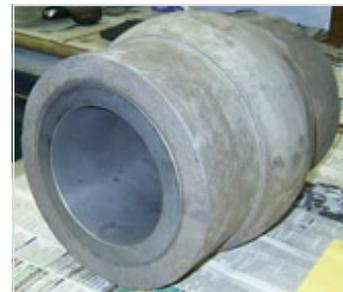
Using the imprint code from the outside of the casting, Graphite Metallizing was able to identify the pillow blocks used in the unit. The maintenance manager at the condominium complex removed two of the pillow blocks and drove the insert assemblies to the Graphite Metallizing manufacturing facility in Yonkers. Once the units were disassembled, the original bushings proved to still be functional after 20+ years of operation in the abrasive conditions. The old bushings were removed and new GRAPHALLOY bushings were manufactured and installed in the housing.

After two decades of reliable service, the GRAPHALLOY® bushings in this wastewater treatment plant were replaced with new GRAPHALLOY bushings. The original bushings were still providing service 20+ years after installation.
