Food Applications: Tough Environments for Bearings

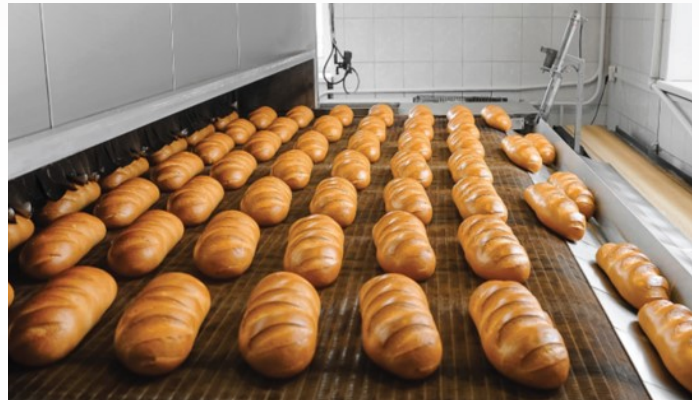
GRAPHALLOY pillow block, flange block assemblies, inserts have the following advantages:

- ◇ **Self-lubricating:** Requires no grease or oil. Eliminates downtime.
- ◇ **Temperature Range:** Performs in temperatures from -400°F to +1000°F (-240 to +535°C).
- ◇ **Direct replacement inserts** for industry standard pillow and flange block assemblies.
- ◇ **Withstands Steam and Pressure Washes**
- ◇ **FDA Acceptable Grades Available**
- ◇ **(EC) No. 1935/2004 Grades Available**

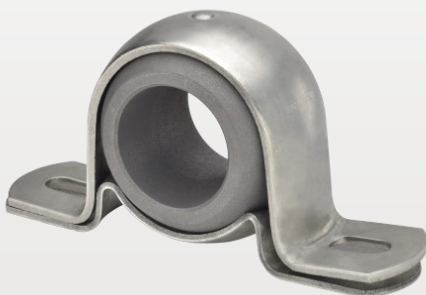
Commercial Bakery Solves Weekly Failures

The bakery uses two continuous belt-type baking ovens. A typical operating temperature is 525°F. The steel belts in the ovens are 145 feet long, 4 feet wide and travel at 55 FPM. Conventional oil lubricated cam followers only lasted one week in such a high temperature environment. They replaced 16 to 20 burned out cam followers every week for a year. They upgraded to GRAPHALLOY cam followers which went sixteen weeks (and counting) with no sign of wear. Both of their ovens are now equipped with Graphalloy.

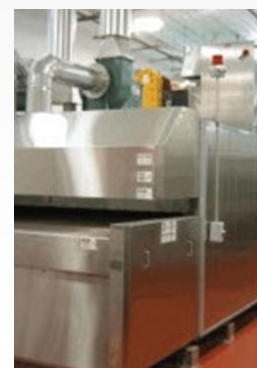
A bakery oven OEM was using rolling element bearings on the conveyor circuit of a tunnel oven with a temperature range from 450°F to 650°F. To reach these bearings, mechanics would have to crawl over the oven belt when the machine was shut down, thus causing damage and presenting a safety risk. Another issue was caustic washdowns that rusted the ball bearings. In some applications, bearing life was as little as 2 weeks. They were researching solutions when they discovered GRAPHALLOY. Now, Graphalloy bushings in stainless steel pillow block housings have been running in this application for several years with no issues.

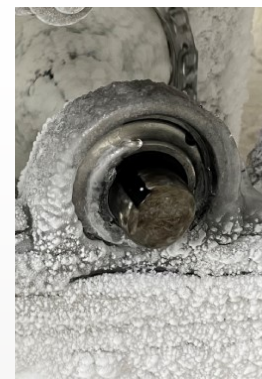
A seafood processing plant in the Southeast was running a conveyor in their freezer area to "flash-freeze" fresh seafood. The environment is a difficult one: it is cold (28°F/-2°C) and wet and the system requires frequent washdown. The conveyor bearings were being replaced every month. The plant maintenance superintendent contacted GRAPHALLOY about the problem. It was determined that the current bearings could not hold lubrication under these conditions and, as a result, breakdowns were occurring frequently. Graphalloy 4-bolt flange block assemblies were installed and have been running successfully for 5+ years!
