# GRAPHALLOY® Bearings for Food Applications

DS2529-44

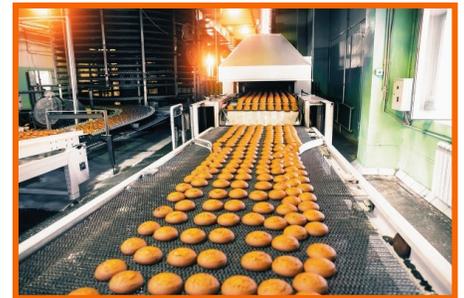
## Oven Manufacturer Solves Major Maintenance Problem

A bakery oven OEM was using rolling element bearings on the conveyor circuit of a tunnel oven with a temperature range from 450°F to 650°F. To reach these bearings, mechanics would have to crawl over the oven belt when the machine was shut down, thus causing damage and presenting a safety risk. Another issue was caustic washdowns that rusted the ball bearings. In some applications, bearing life was as little as 2 weeks. They were researching solutions when they discovered GRAPHALLOY. Graphalloy self-lubricating bushing materials thrive in high temperature environments, handle caustic washdowns, and are maintenance-free. These Graphalloy bushings in stainless steel pillow block housings have been running in this application for several years with no issues.

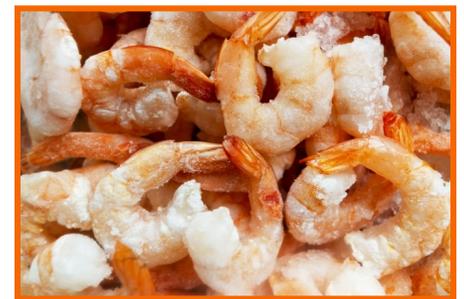
## Seafood Freezer Conveyor Extends Bearing Life by 30x

A seafood processing plant in the Southeast was running a conveyor in their freezer area to “flash-freeze” fresh seafood. The environment is a difficult one: the temperature is cold (28°F/-2°C) and wet and the system requires frequent washdown. The conveyor bearings were being replaced every month. The plant maintenance superintendent contacted GRAPHALLOY about the problem. It was determined that the current bearings could not hold lubrication under these conditions and, as a result, breakdowns were occurring frequently. Graphalloy 4-bolt flange block assemblies were installed and have been running successfully for more than five years!
